Insulation Failure Mechanisms of Power Generators

Rudolf Bruetsch

Von Roll Switzerland Ltd., 4226 Breitenbach, Switzerland

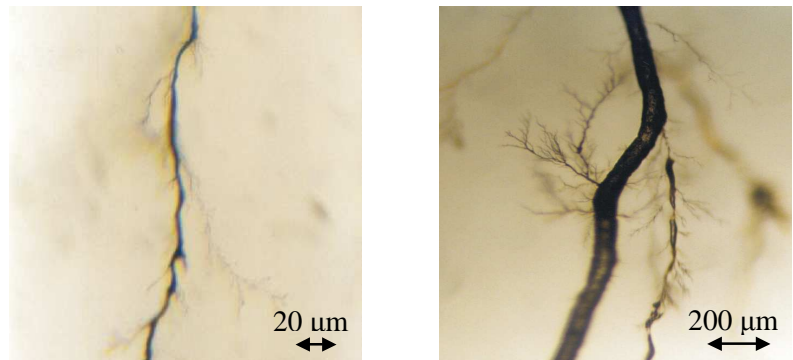
Figure 4. A small tree (left) and a broader tree channel (right) which is sufficiently conductive for breakdown

Treeing and the formation of branches started immediately after voltage application. Propagation of the trees towards the grounded electrode was detained by the embedded mica tape, trees continued to propagate on the surface of the mica tape instead which required most of the total breakdown time. When the tape edge was reached treeing continued rapidly heading for the grounded electrode. Breakdown did not occur immediately after the first branches reached the ground. More branches were generated and the diameter of the tree channels increased up to 50-200 μm . At this stage conductivity and continuity of the tree channels were sufficient to cause breakdown (Figure 4). Measured average breakdown times were around 50 - 100 hours. In all experiments trees could only penetrate the mica tape if it was damaged, e.g. by bending or folding.

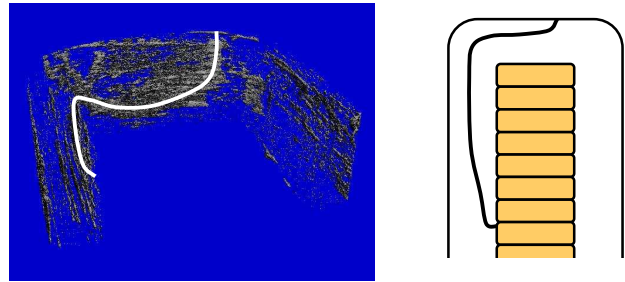
1 m long model bars with an insulation thickness of 2 mm prepared with VPI and resin-rich technology were used for $3U_n$ voltage endurance tests (Figure 5). The voltage applied was 32 kV AC. To verify if electrical trees can be found in the mica insulation sections of the bars were examined by X-ray methods. Figure 6 shows an example of a bar section; the tree is accented graphically. The tree path could also be traced by burning off the binder resin of the mica insulation in an oven and carefully removing layer by layer of the mica tape. Applying both methods it was found that the tree mostly started at the edge of the copper conductor stack which can easily be explained by the increased electric field

strength at this point. While the tree was propagating it never went straight to the outer grounded electrode, but followed the edges of the mica tape, at least to some extent.

Figure 6. Tree path in a $3U_n$ model bar uncovered by X-ray methods (left) and traced by burning off the binder resin and removing the layers of mica tape (right).

We assume that the tree was able to "take shortcuts" at places where the mica insulation had imperfections or defects such as voids, cracks, delaminations, resin accumulations at tape overlaps and wrinkled or damaged mica layers. Such defects abet the formation and propagation of trees in the mica insulation and thus reduce its lifetime. These assumptions could be confirmed by micrographs of the mica insulation showing many defects (Figure 7). These findings are in good agreement with the results of the needle-plane experiments, where we observed that the electrical tree is not able to penetrate the mica tape if it is undamaged, but can easily break through if the tape had been bent or kinked before embedding in the needle-plane test specimen.

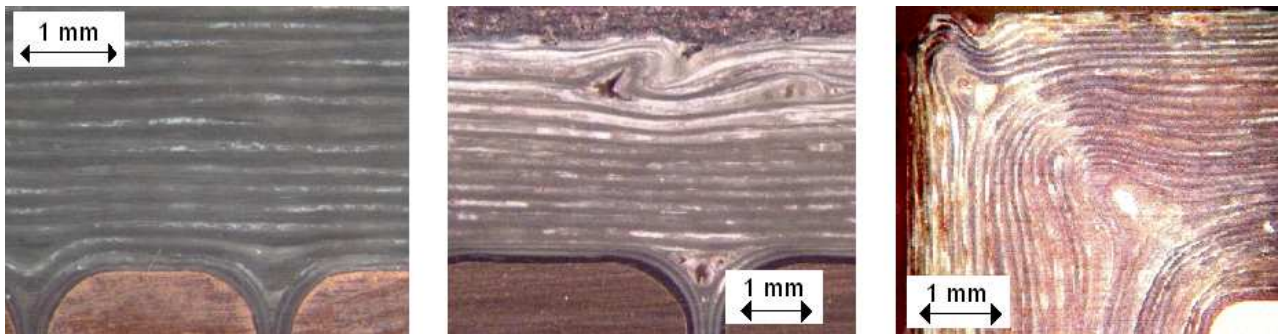
Figure 7. Perfect mica insulation (left) and mica insulation showing various defects (two micrographs on the right) such as voids, wrinkled and folded mica tapes

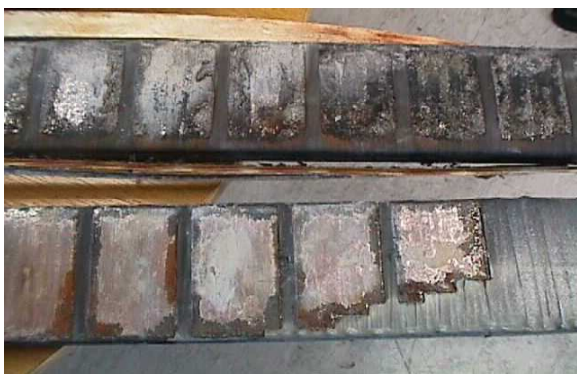
The vibration experiments did not include mechanical abrasion of the slot corona protection as the sample bars were not placed in a slot model. Abrasion of the conductive layer in the slot by the sharp edges of the laminated stator core is an additional factor damaging the insulation and reducing its lifetime, especially if the wedging of the bar in the slot becomes loose. As a consequence partial discharge occurs, adding chemical degradation of organic insulation materials to the mechanical erosion caused by vibration. In literature, this vicious circle is considered one of the main causes of premature failure of high voltage rotating machines [2]. Figure 15 shows the impact of vibration, the slot corona protection is worn except for the positions of the air ducts.

Figure 15. Abrasion of the slot corona protection due to vibration

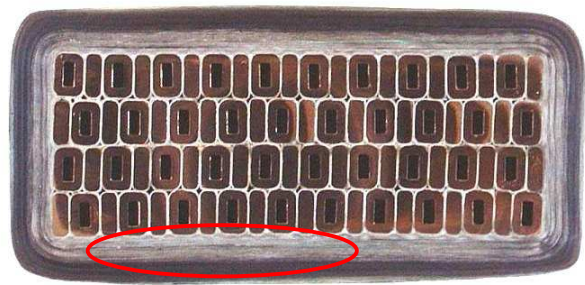
Figure 16. Discoloration of the mica insulation due to leakage of cooling water [10]

Leakage of cooling water in directly cooled generators is also known to deteriorate the main wall insulation [10]. This type of damage could be detected in cross sections of the affected mica insulation by a distinctive discoloration (Figure 16).

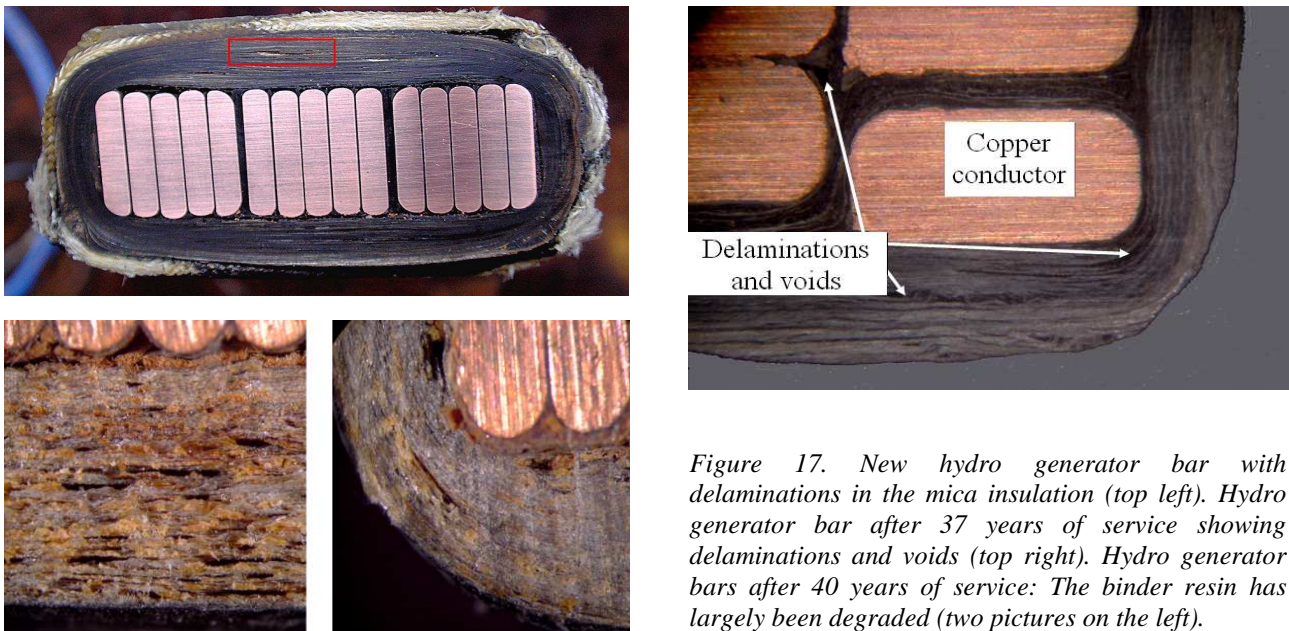
Used and new original hydro generator bars of different origin were available for investigation. Voltage endurance tests, visual and microscopic inspection were carried out to compare results with the findings of the laboratory test samples. Figure 17 gives micrographs of bar sections in different phases of ageing showing delaminations and voids.

Figure 17. New hydro generator bar with delaminations in the mica insulation (top left). Hydro generator bar after 37 years of service showing delaminations and voids (top right). Hydro generator bars after 40 years of service: The binder resin has largely been degraded (two pictures on the left).
