Insulation Failure Mechanisms of Power Generators

Rudolf Bruetsch

Von Roll Switzerland Ltd., 4226 Breitenbach, Switzerland

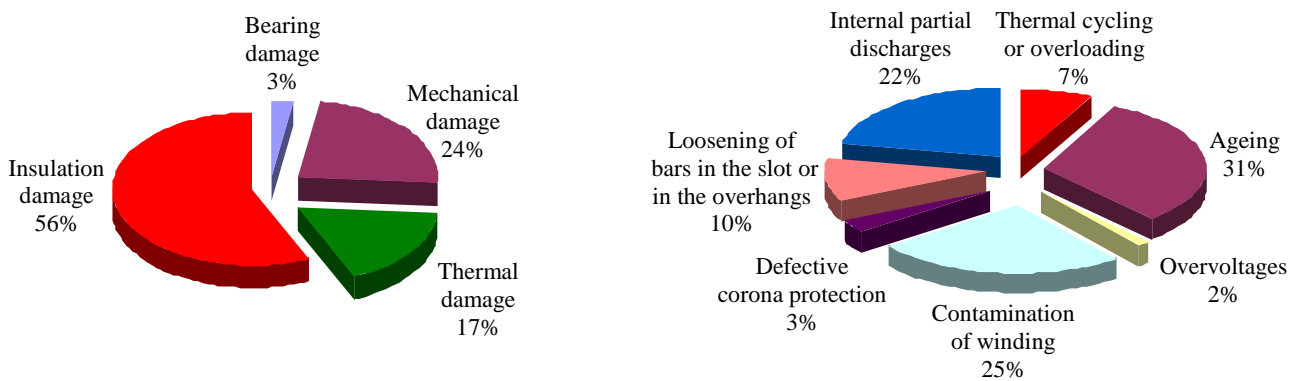
Figure 1a and 1b. Damages of hydrogenerators (left) and root causes of insulation damages (right) [5]

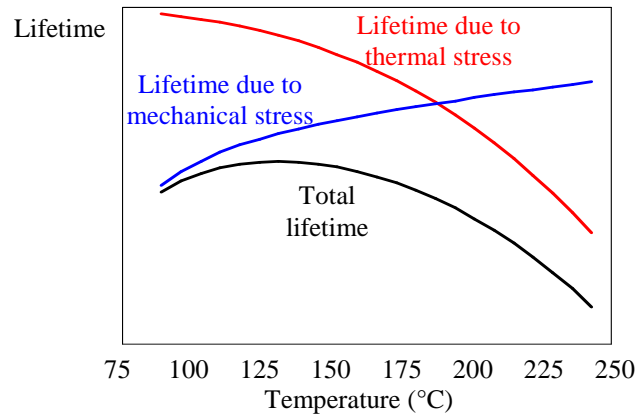
1. Although electric breakdown is causing the final failure of the electrical insulation, electrical stress is not the dominating ageing factor. It is rather believed that the ageing mechanism is dominated by thermal degradation of the binder resin, mechanical stress caused by vibration and switching pulses and stress caused by the different thermal expansion coefficients of the materials involved.
2. Ageing under thermal, mechanical and electrical stress shows an increase in lifetime at moderate temperatures up to approximately 130°C and a rapid decrease if the ageing temperature is increased up to 180°C (Figure 2).

Figure 2. Schematic graph showing the lifetime of mica insulation as a function of thermal stress (red curve), mechanical stress (blue curve) and their interaction (black curve).

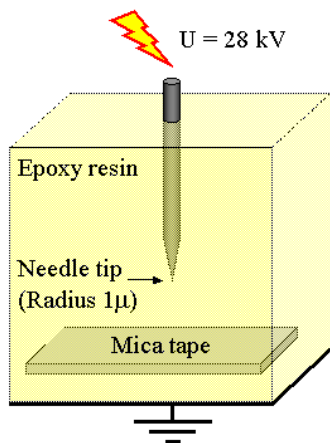
The needle-plane arrangement in epoxy cubes allows direct observation of the phenomenon of electrical treeing. Test samples as shown in figure 3 with an edge length of the epoxy cubes of about 4 cm were prepared. The size of the mica tape was 2 x 4 cm. Electrical tree propagation was monitored with a video camera.

Figure 3. Needle-plane test sample

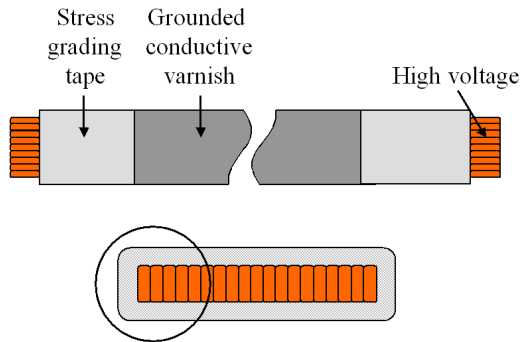
1 m long model bars with an insulation thickness of 2 mm prepared with VPI and resin-rich technology were used for $3U_n$ voltage endurance tests (Figure 5). The voltage applied was 32 kV AC. To verify if electrical trees can be found in the mica insulation sections of the bars were examined by X-ray methods. Figure 6 shows an example of a bar section; the tree is accented graphically. The tree path could also be traced by burning off the binder resin of the mica insulation in an oven and carefully removing layer by layer of the mica tape. Applying both methods it was found that the tree mostly started at the edge of the copper conductor stack which can easily be explained by the increased electric field

strength at this point. While the tree was propagating it never went straight to the outer grounded electrode, but followed the edges of the mica tape, at least to some extent.

Figure 5. $3U_n$ model bar used for voltage endurance tests. Treeing was investigated in the encircled section.

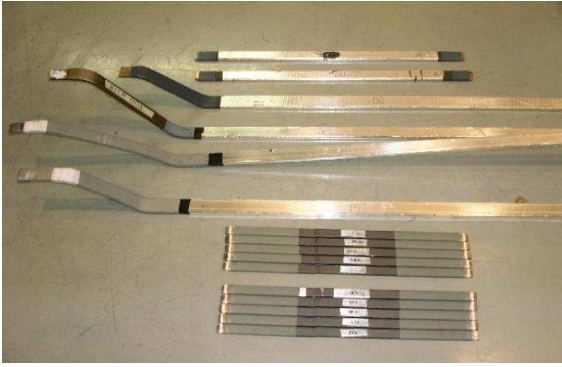
It is therefore obvious that the manufacturing quality of the mica insulation has an influence on the lifetime of the coil or bar. Several voltage endurance tests were done to demonstrate this using different bar types as shown in figure 8. The resulting Weibull plots are given in figures 9 - 11. Figure 9 compares the lifetimes of bars manufactured under industrial conditions and bars made in the laboratory. Applying the mica insulation carefully on model bars in the laboratory results in a slight increase of the characteristic lifetime. Figure 10 shows the lifetime of bars which were manufactured applying a poor and a correct VPI impregnation process. Poor impregnation gave a mica insulation with lots of voids, the characteristic lifetime of the sample bars investigated was reduced by a factor 10. Figure 11 gives the difference between bars with and without wrinkles in the mica insulation. Again, the difference in lifetime is significant. Manufacturing defects and treeing paths in the mica insulation of the different bars were analysed as described above. We conclude that these defects enhance the formation and propagation of electrical trees and thus reduce the lifetime of the insulation.

Figure 8. Different types of model bars used for voltage endurance measurements

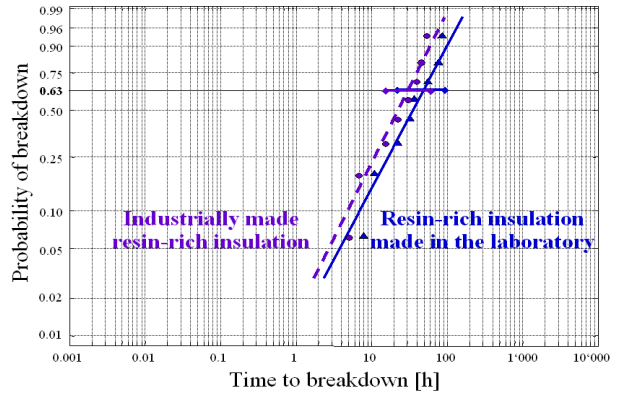
Figure 9. Voltage endurance of industrially made bars and model bars made in the laboratory

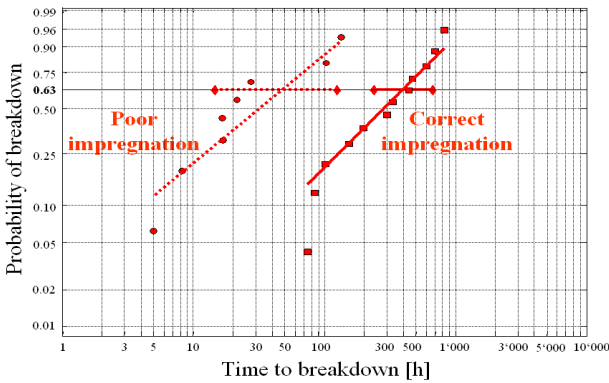
Figure 10. Influence of the VPI impregnation quality on voltage endurance

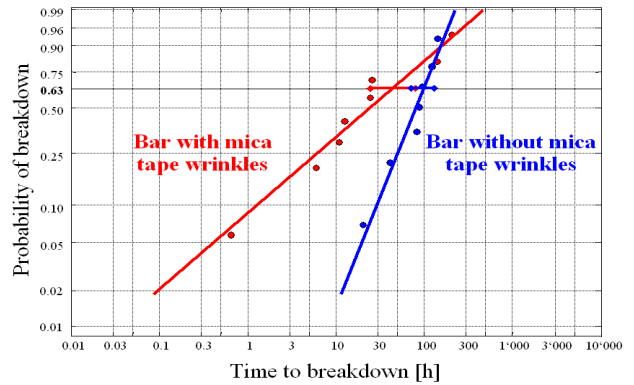
Figure 11. Voltage endurance of generator bars with and without wrinkled mica tape layers

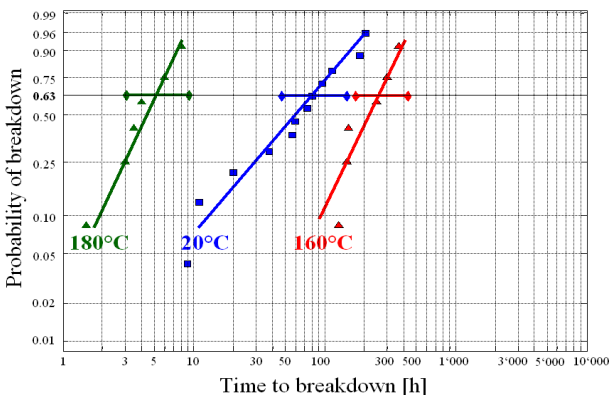
In the introduction it was stated that thermal and mechanical stress are the dominating ageing factors of the insulation in high voltage rotating machines. Therefore a large number of voltage endurance tests was performed to investigate the two stress factors. Figure 12 shows the influence of the ageing temperature on voltage endurance investigated in a combined thermal / electrical ageing test. Results show that the lifetime of the insulation is higher at 160°C than at 20°C which is in accord with the statements cited above [6, 7]. This can be explained by a higher flexibility of the binder resin at elevated temperature which minimises the risk of crack formation, but also by the reduction of internal stresses coming from the curing reaction which usually takes places at temperatures around 160°C. It may also be that the longer life at 160°C is due in part to a post curing effect that occurs at the higher temperature. However, at 180°C thermal degradation of the binder resin is the dominating ageing factor and lifetime of the model bars was considerably reduced. According to T. Weiers [8] the optimal ageing temperature for maximum lifetime of epoxy based mica insulations is about 90°C, which is within the usual operating range of large power generators.

Figure 12. Influence of the ageing temperature on voltage endurance

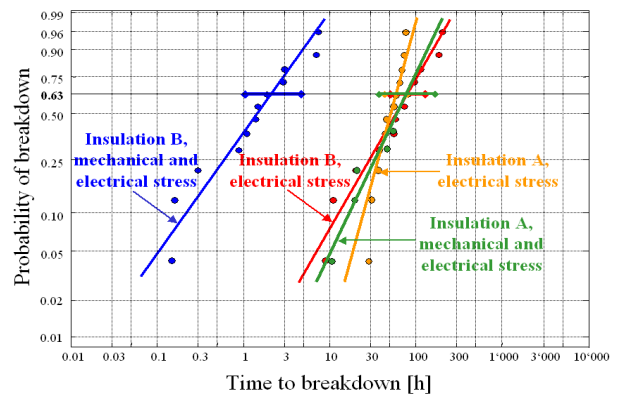
Figure 13. Influence of mechanical stress (vibration) and type of insulation on voltage endurance

Two different insulating materials were used for the vibration tests: Insulation A, a combination of a glass-backed mica tape and an epoxy based VPI resin which is mostly used for large power generators, and insulation B, a combination of a polyesterfilm/-fleece backed mica tape and a polyester based VPI resin. Results show that the lifetime of insulation B was reduced through vibration by a factor around 10, whereas the lifetime of insulation A was not altered (Figure 13). Micrographs of insulation B show delaminations parallel to the mica layers which are supposed to trigger and accelerate treeing; but the formation of cracks perpendicular to the mica layers could not be observed. Polyester resins are known to give a lower adhesion and a higher shrink during curing compared to epoxies. This effect is enhanced by the mica tape used for insulation B; polyesterfilm as a carrier material results in a lower mechanical strength of the insulation than glass fabric.

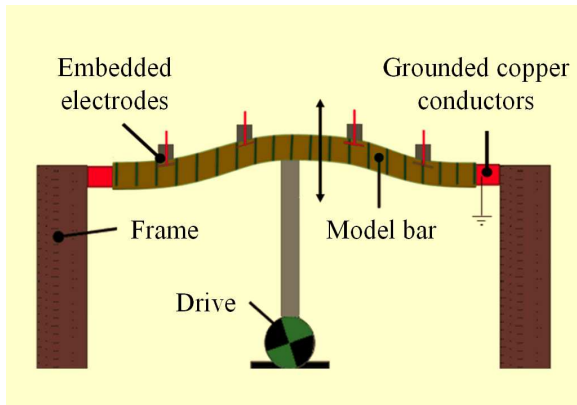
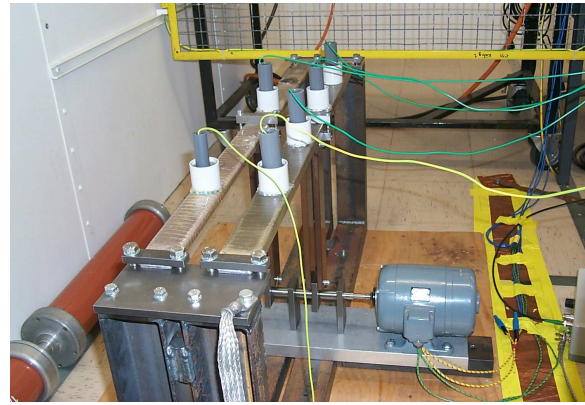
Figure 14. Vibration test equipment. Voltage was applied to the model bars by embedded electrodes.

Mechanical stress is exerted on the insulation of high voltage rotating machines due to vibration, different thermal expansion coefficients of the materials involved as well as transient and centrifugal forces. Vibration experiments were conducted on 1 m long sample bars using a vibration equipment which allowed 100 Hz vibrations with an amplitude of ± 0.5 mm (Figure 14). Insulation life was measured applying vibrational and electrical stress simultaneously and compared to bars exposed to electrical stress only. Voltage was applied to the bars by embedded electrodes. They were set directly into the insulation in order to avoid any surface discharges. The sharp edges of the electrodes initiated tree inception immediately after voltage application. Insulation thickness and voltage applied were the same as for the 3Un model bars (2 mm, 32 kV AC). The advantage of this test method is that up to four breakdown measurements can be performed with one bar. R. Vogelsang [9] proved that voltage endurance results obtained with the method of embedded electrodes agree with lifetimes measured according to IEEE 1043.

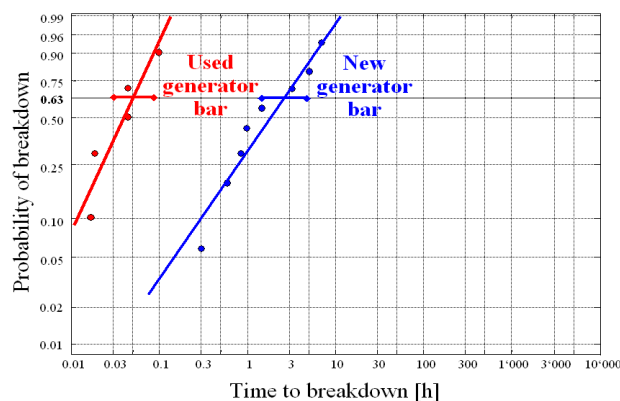
The depletion of lifetime through ageing is shown in figure 18 comparing the voltage endurance of used, but still functional generator bars with new ones. The remaining lifetime of the used bars is drastically reduced.

Figure 18. Comparison of new with used, but still functional generator bars
